UNDERWATER FACILITIES

INSPECTION AND ASSESSMENT

**DEPERMING PIER  
TRIDENT REFIT FACILITY  
BANGOR, WASHINGTON**

January, 1985

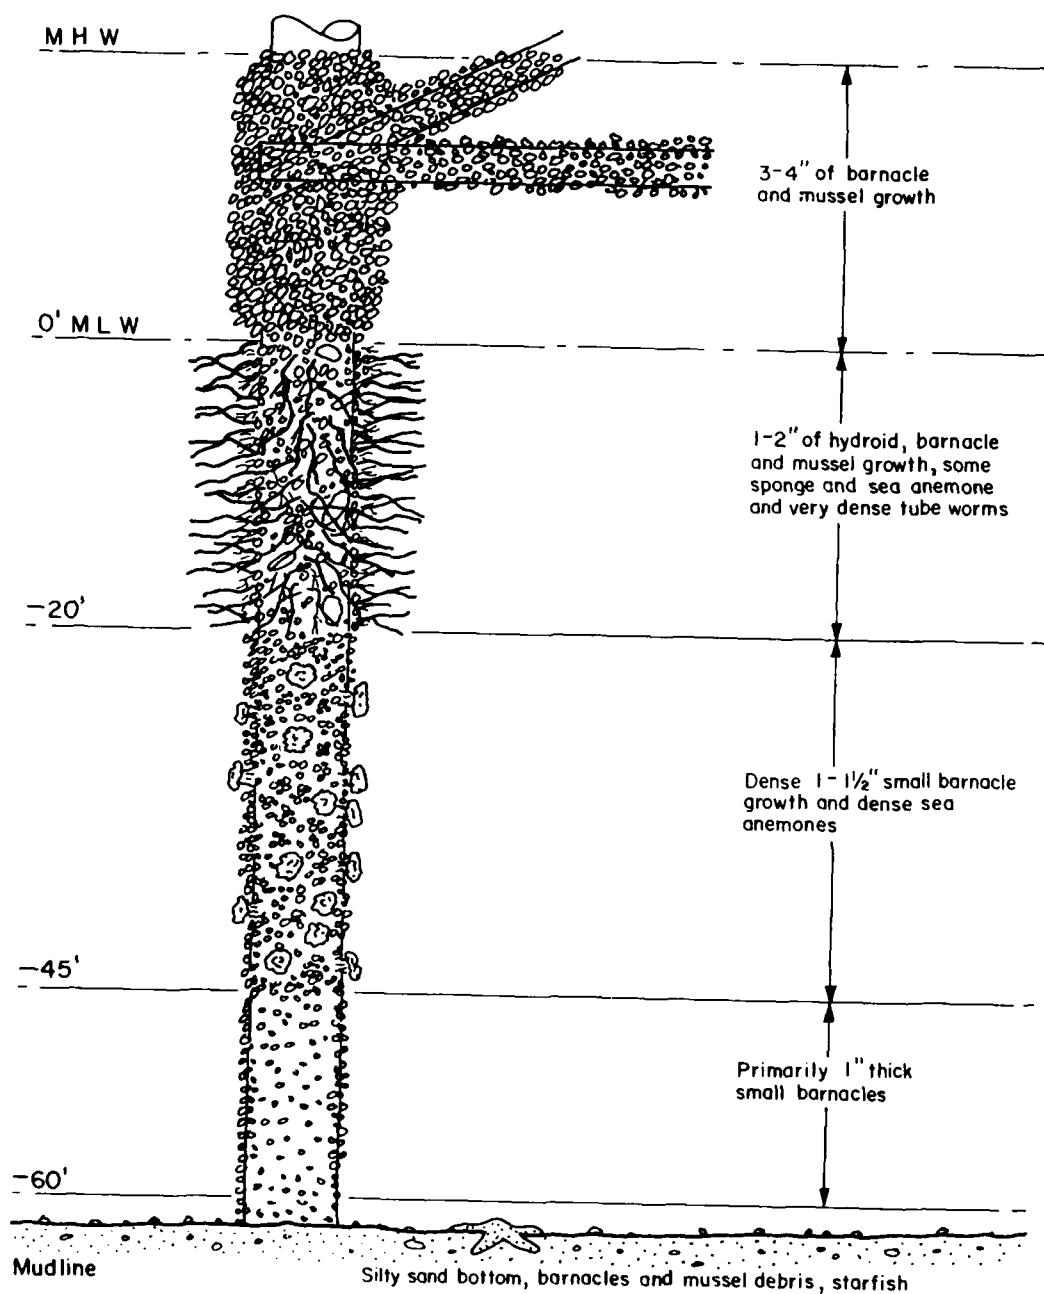
J. Agi & Associates Co. Ltd. Suite 600, 1414 Alaskan Way, Seattle, WA		CHESNAVFACENGCOM	
Not to scale		MARINE GROWTH PROFILE	
January, 1985.		MAGNETIC SILENCING FACILITY BANGOR, WA.	
		Fig. 1

Extensive marine fouling growth was found throughout the inter-tidal and immersed zones with an observed significant increase in growth since a previous 1980 inspection. Specifically the fouling growth pattern was as follows:

Intertidal zone	-	Dense barnacle and mussel growth
Upper immersed zone (0' to -20')	-	Primarily dense tubeworms also hydroids, barnacles, mussels, sea anemones and sponges.
Lower immersed zone (-20' to -45')	-	Dense, 1" - 1 1/2", barnacle growth and dense sea anemones.
Mudline	-	Primarily dense barnacle cover.

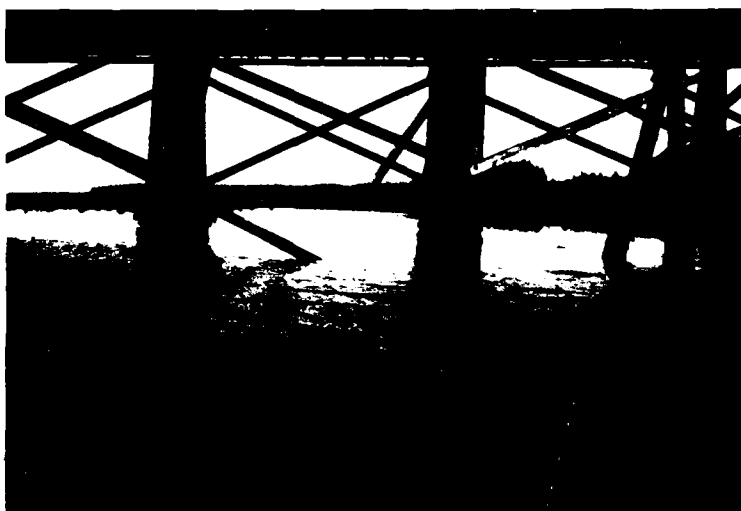
PHOTOGRAPH NO. 4

Broken diagonal brace timber - Row 3, Bent 23-24 South Diagonal of Approachway. All other braces are undamaged.
